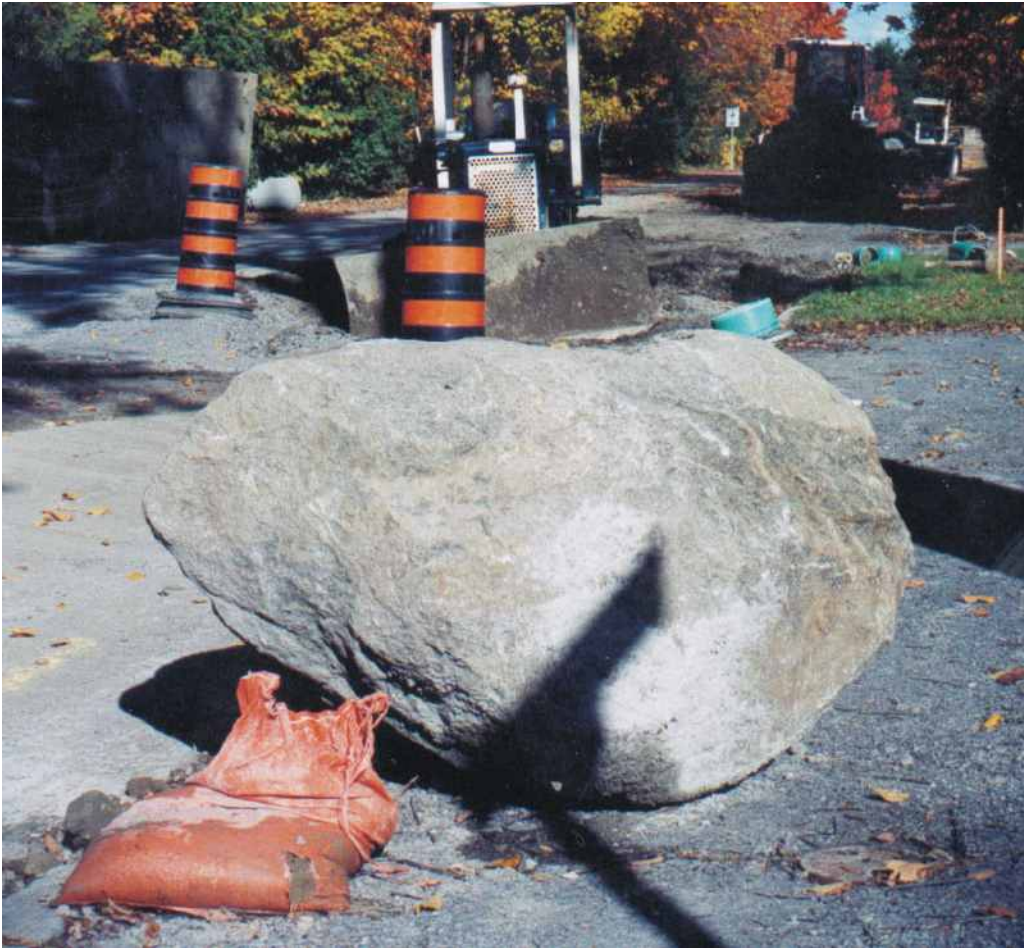
Photo 16. Location 5-a, Birch Avenue at corner with Hemlock Road. Erratic boulder dug from marine clay (unit 5) beneath Birch Avenue, October 2003. Boulder is composed of layered crystalline gneiss, a rock metamorphosed (changed) under conditions of high temperature and pressure. Similar rock is associated with granites in the Gatineau Hills.
